DEPARTMENT OF TRANSPORTATION**DIVISION OF ENGINEERING SERVICES**

Office of Structural Materials

Quality Assurance and Source Inspection

Contract #: 04-0120F4Cty: SF/ALA Rte: 80 PM: 13.2/13.9File #: 69.28**WELDING INSPECTION REPORT****Resident Engineer:**Pursell, Gary**Address:** 333 Burma Road**City:** Oakland, CA 94607**Report No:** WIR-002673**Date Inspected:** 23-May-2008**Project Name:** SAS Superstructure**OSM Arrival Time:** 630**Prime Contractor:** American Bridge/Fluor Enterprises, a JV**OSM Departure Time:** 1530**Contractor:** Zhenhua Port Machinery Company, Ltd (ZPMC), Changxing Island **Location:** Shanghai, China**CWI Name:** Ye Yong Jun and Lvliqing**CWI Present:** Yes No**Inspected CWI report:** Yes No N/A**Rod Oven in Use:** Yes No N/A**Electrode to specification:** Yes No N/A**Weld Procedures Followed:** Yes No N/A**Qualified Welders:** Yes No N/A**Verified Joint Fit-up:** Yes No N/A**Approved Drawings:** Yes No N/A**Approved WPS:** Yes No N/A**Delayed / Cancelled:** Yes No N/A**Bridge No:** 34-0006**Component:** OBG and SAS Tower Fabrication**Summary of Items Observed:**

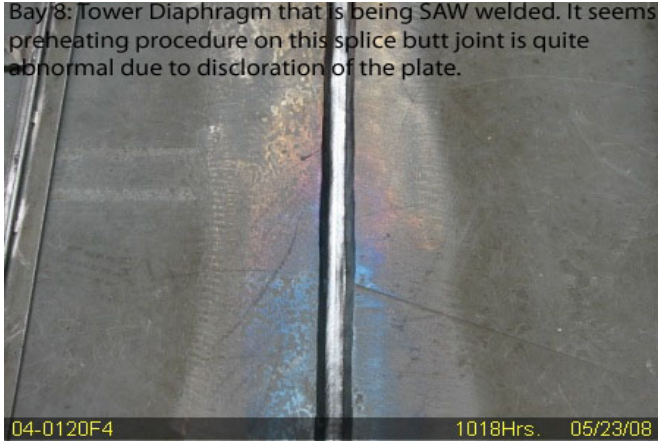
Bay 8: Lower Diaphragm that is being SAW welded. It seems preheating procedure on this splice butt joint is quite abnormal due to discoloration of the plate.

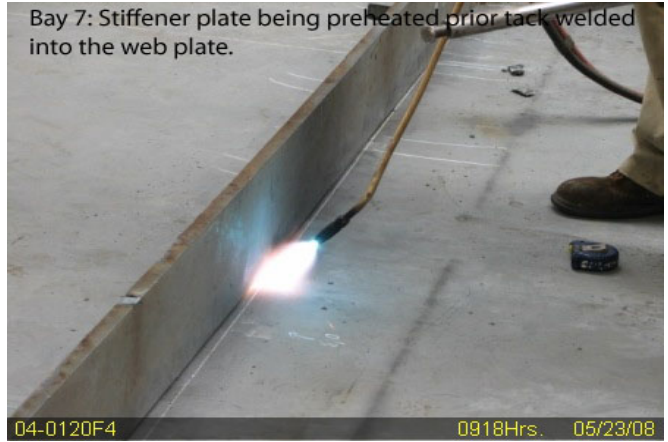
Bay 7: Stiffener plate being preheated prior tack welded into the web plate.
